## ***LUEDERS WATER SYSTEM IMPROVEMENTS JONES COUNTY, TEXAS***

Texas Antiquities Permit Number 8066

Cultural Resources Report 2017-53  
August 22, 2017

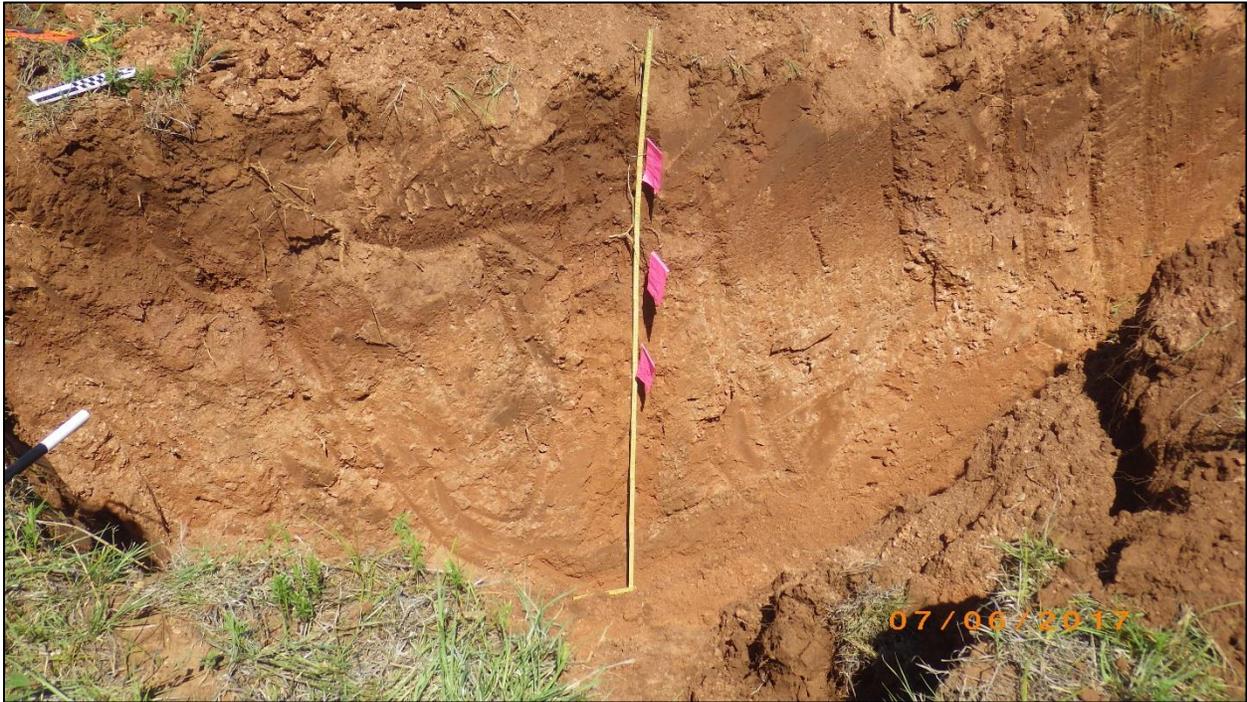
Figure 11. BHT1 profile on west wall.

As previously mentioned, ST1-4 on the south side of the river, appear to closely match the Miles series soil descriptions for terrace deposits, although the description has no mention of gravels in these sediments (Table 3). This general profile was the same for BHT1 (Figure 11). This trench was roughly oriented north/south as was a little over 12 m long and nearly 2 m deep (Figure 12). While gravels were found throughout the trench, the size of the gravels increased with depth.

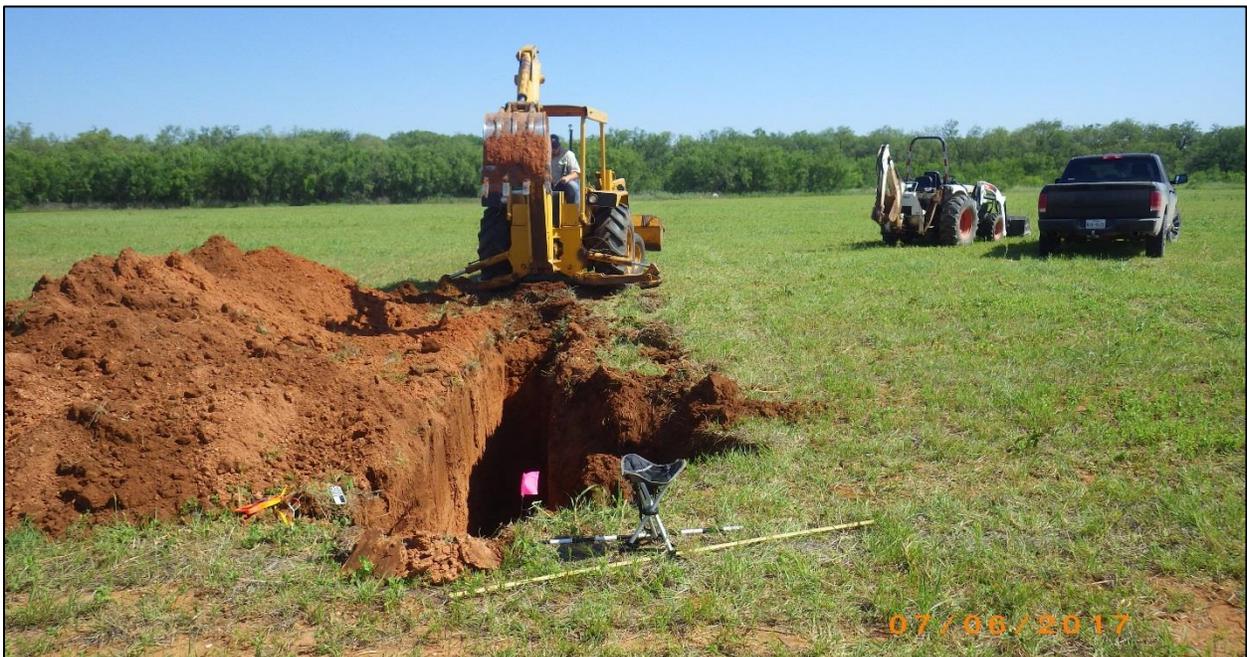
Figure 12. Overview of BHT1 looking north.

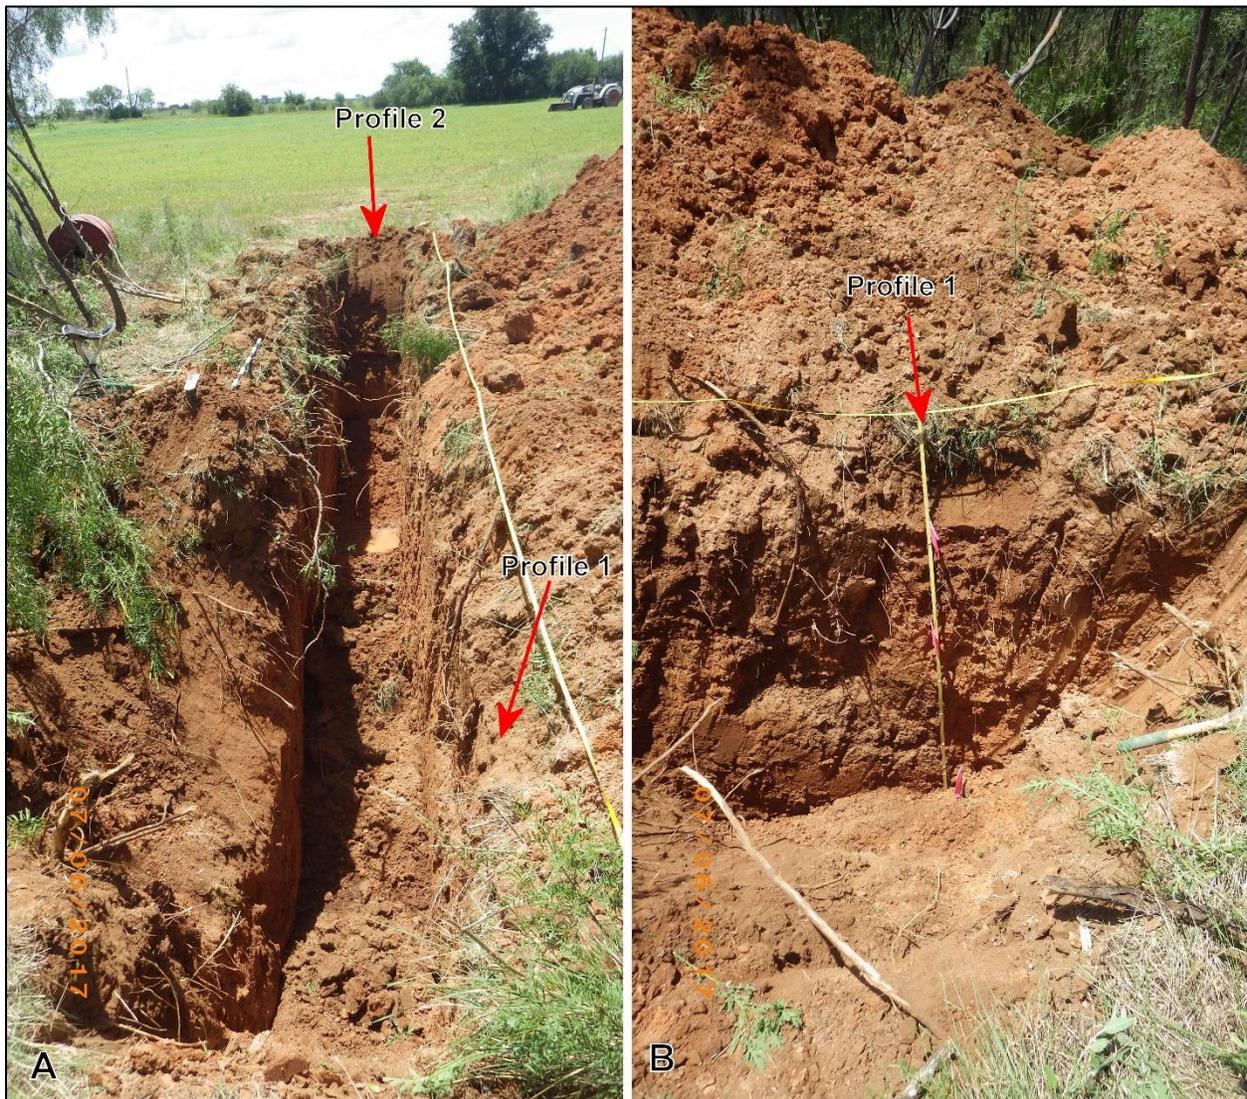
Figure 13. A. Overview of BHT2 looking south, with both profile locations noted. B. View of Profile 1 in BHT2 on west wall.

BHT2 was excavated at the vegetation change marked by the USGS contour. The trench was approximately 10 m long and 2 m deep (Figure 13A). The water table was encountered around 150 cm below the surface (cmbs), and the bottom quickly filled with water. The trench was started in the north and extended south towards the open pasture, once the open field was encountered in the trench, the sediments in the last meter (Profile 2), looked similar to BHT1, while Profile 1 appeared to be closer to the floodplain description of the Spur Series (Figure 13B). As with the STs and BHT2 gravels were noted throughout the trench.

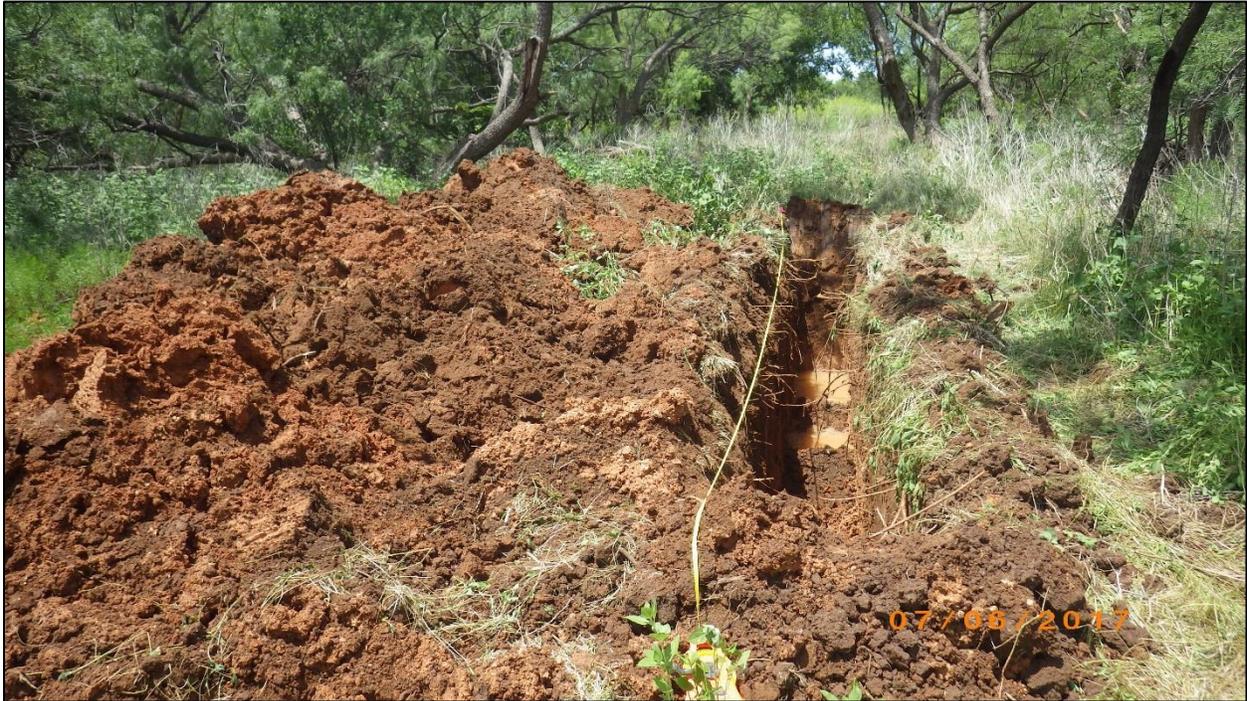
Figure 14. Overview of BHT3 looking north towards wetland. Note water filling in trench.

BHT3 was excavated near ST5 at the transition from the young mesquites to the older and more sparsely spread mesquites (Figure 14). The profile throughout this trench was consistent throughout this 10 m long, 2 m deep trench. Between 60-70 cmbs a sandy flood event was noted in the profile (Figure 15). Additionally, the water table was encountered between 100 and 140 cmbs, the wet sandy clays in the bottom did not have much structure or strength and the trench

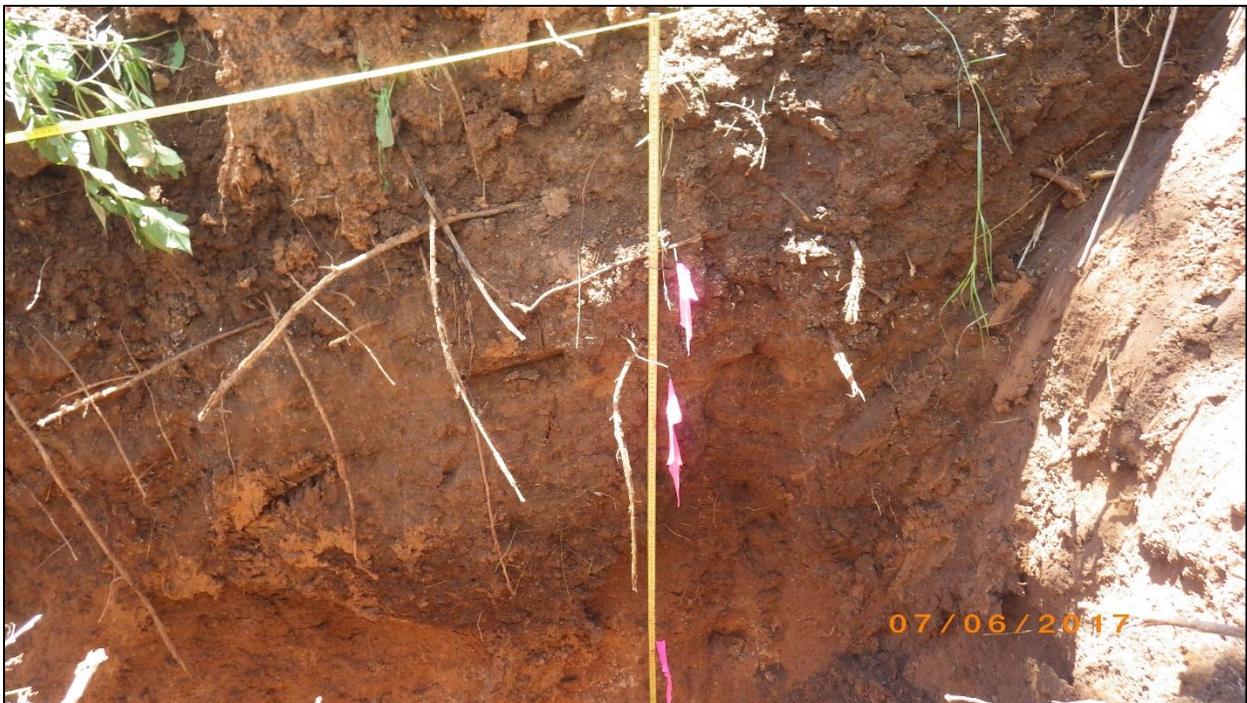
Figure 15. BHT3 profile in west wall.

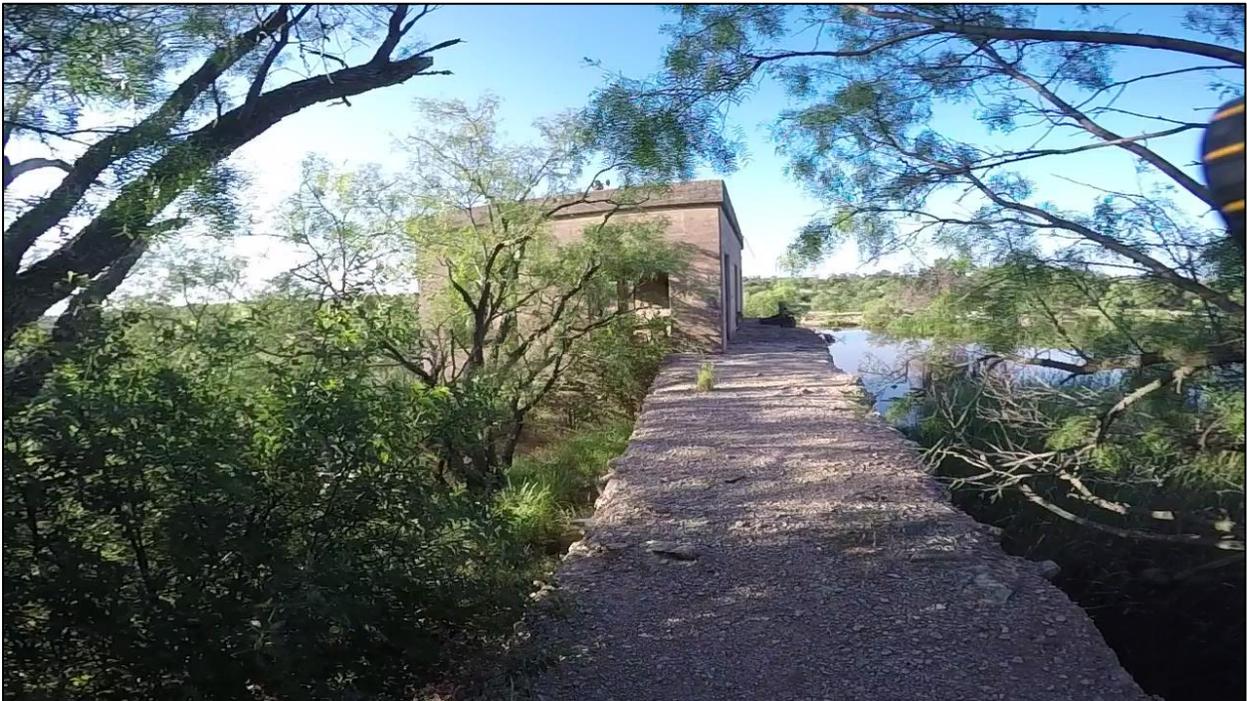
Figure 28. Overview of concrete dam where it adjoins the earthen levee, looking south out to lake and pumphouse.

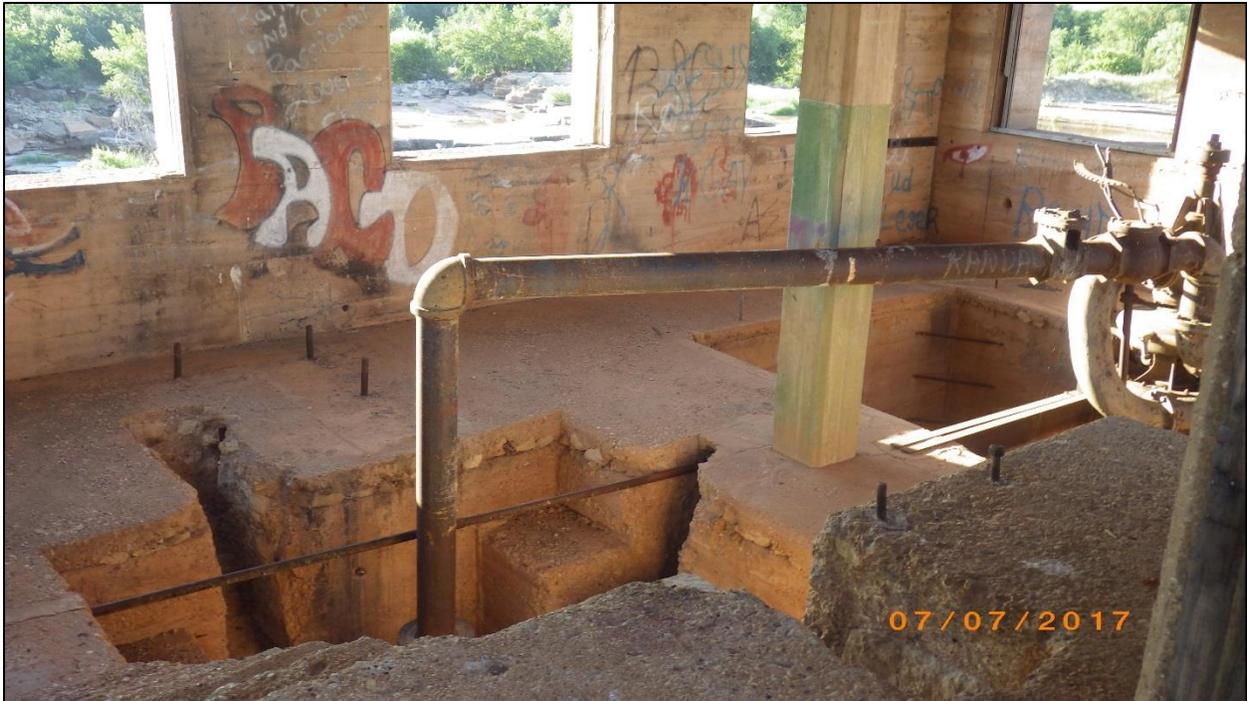
Figure 29. Interior of pumphouse. View is to the southeast.

Overall, the majority of the lake and its associated structures and features are intact as shown on recent Bing Bird's Eye Imagery (Figure 27). While these features are outside the proposed pipeline route, the landowner allowed the author to photograph the site. Figure 28 through Figure 37 are a few of the photos the author was able to obtain while on site. The dam and pumphouse adjoin the earthen levee that runs along the north side of the lake. While the motors and most of the equipment are gone, the pipes on the interior remain (Figure 29). The spillway is concrete and at the time of the survey was flowing (Figure 30). Below the spillway is the exposed bedrock where the stair step waterfalls occur (Figure 31). On top of the dam wall, extending north from the pumphouse, rests a cast-iron pipe that transported the water to the intake structure shown in Figure 32. Here a broken piece of concrete exposed two types of rebar (Figure 33). One of which is Damascus Twist, a type of rebar that dates prior to 1920 (Friedman 1995; Trask and Skinner 2002). This type of rebar has a plain square shape that is then twisted and was originally patented by E.L. Ransome

(Friedman 1995:108). This rebar and the other, were both noted in as being used in the pumphouse and in the dam wall.

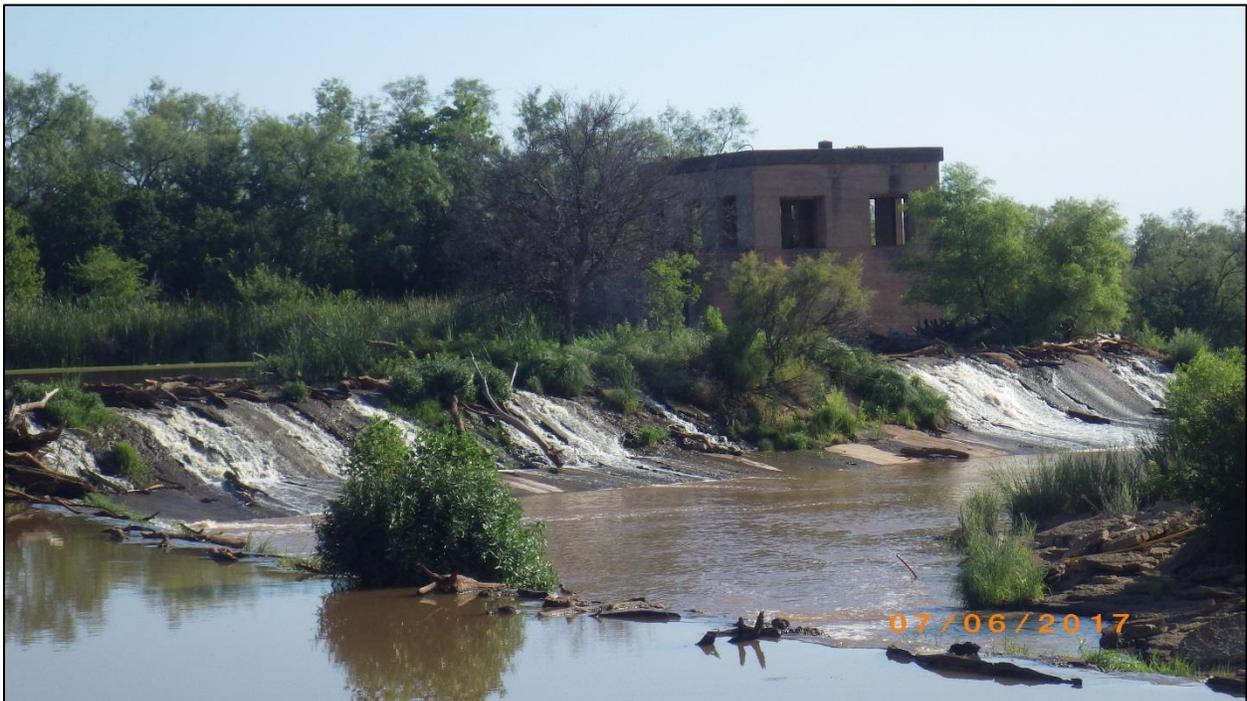
Figure 30. Overview of spillway and pumphouse from south side of river. View is to the north.

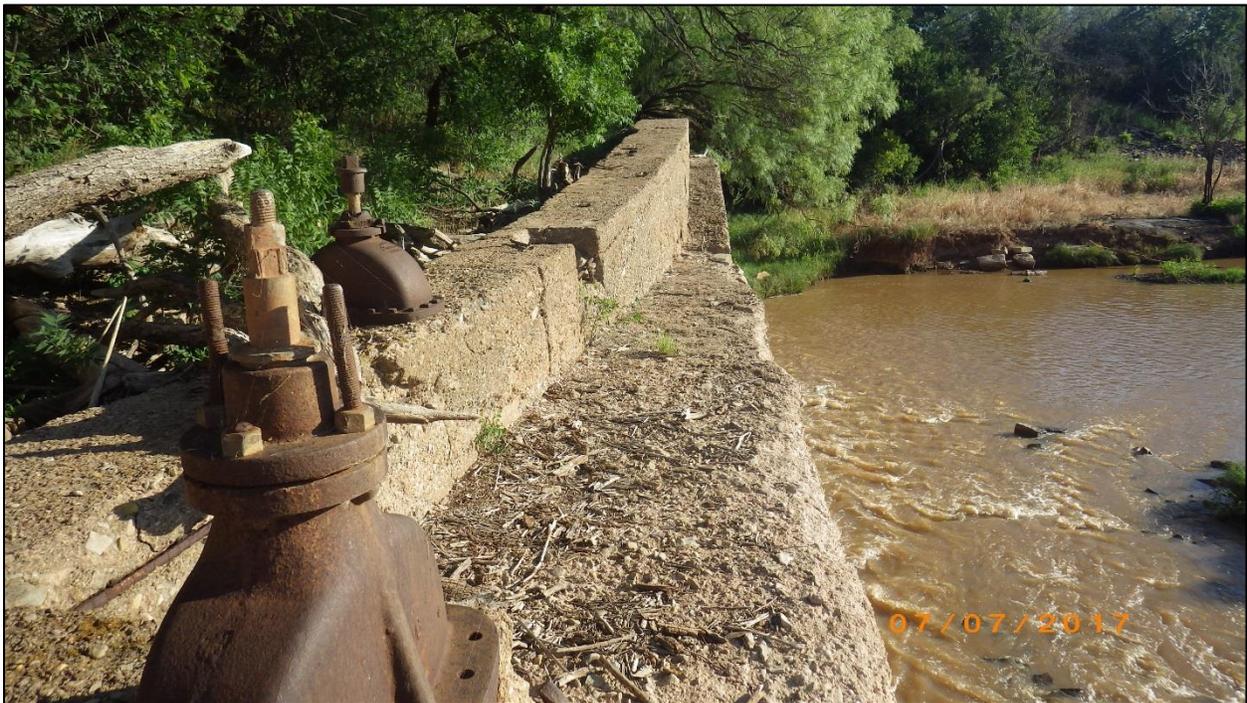
Figure 32. Overview of dam wall extending north from pumphouse. The pipeline from the pumphouse appears to be on top the dam and extends towards the intake structure.

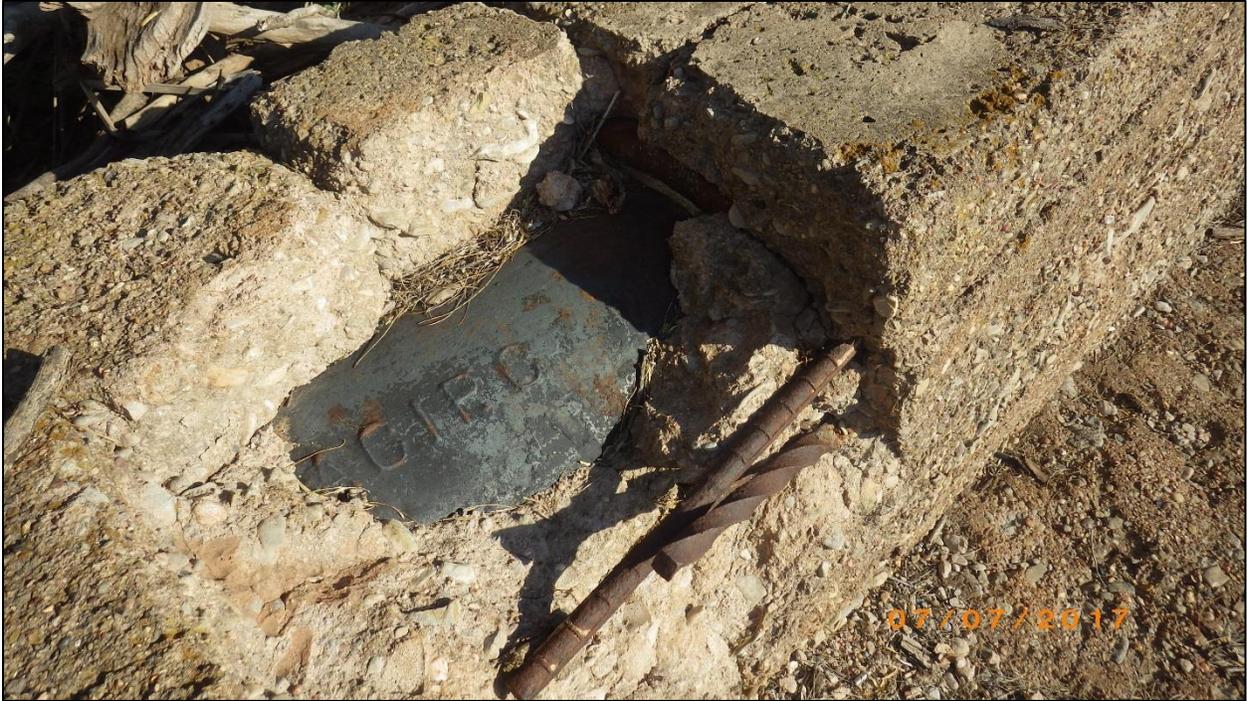
Figure 33. View of broken concrete exposing pipe and two kinds of rebar. Damascus Twist Rebar is present in the structure.

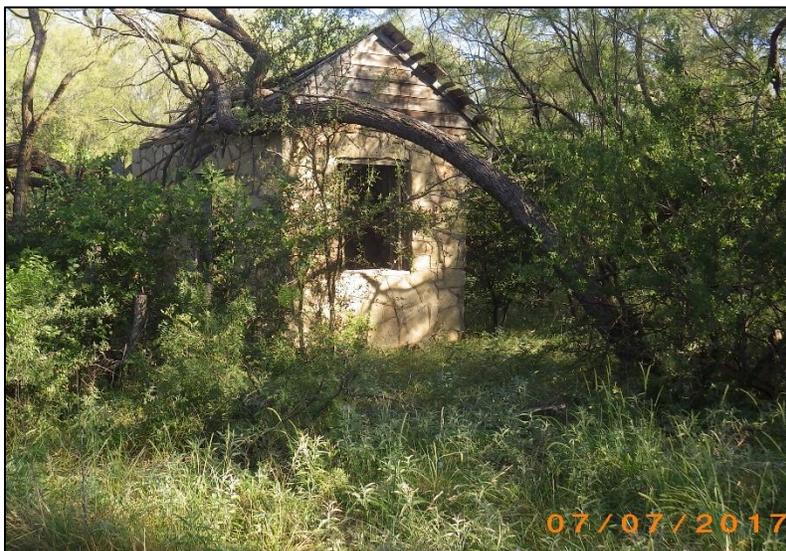
Figure 34. Small motor building northeast of intake structure. View is to the north.

North of the intake structure, is a small building that contained a motor mount (Figure 34). The building was very small, but visible on the aerials. The building was built of Lueders limestone and had a wooden roof (Figure 35). The intake structure was also made from Lueders limestone, but had a red tile roof (Figure 36). As a part of this structure there were six settling basins or tanks (Figure 37), according to Vinson, he thought this is where they originally tried to settle out all the sediment from the water, but it was not sufficient, and the large square basin was built afterwards by the WPA. No other informant or research could verify what all the WPA did at the site.

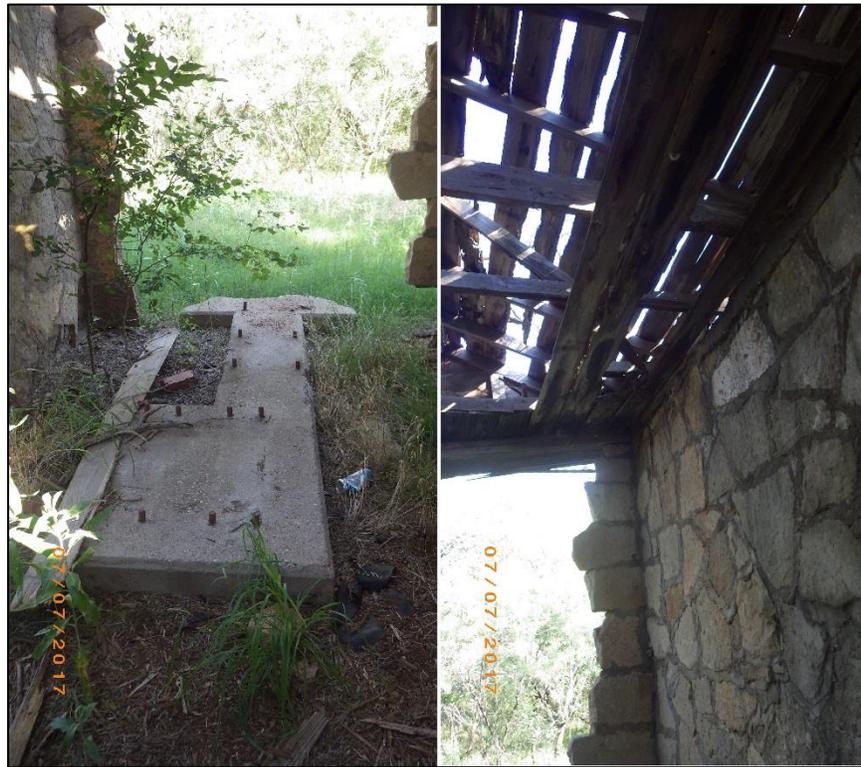
Figure 35. Interior of the small motor structure.

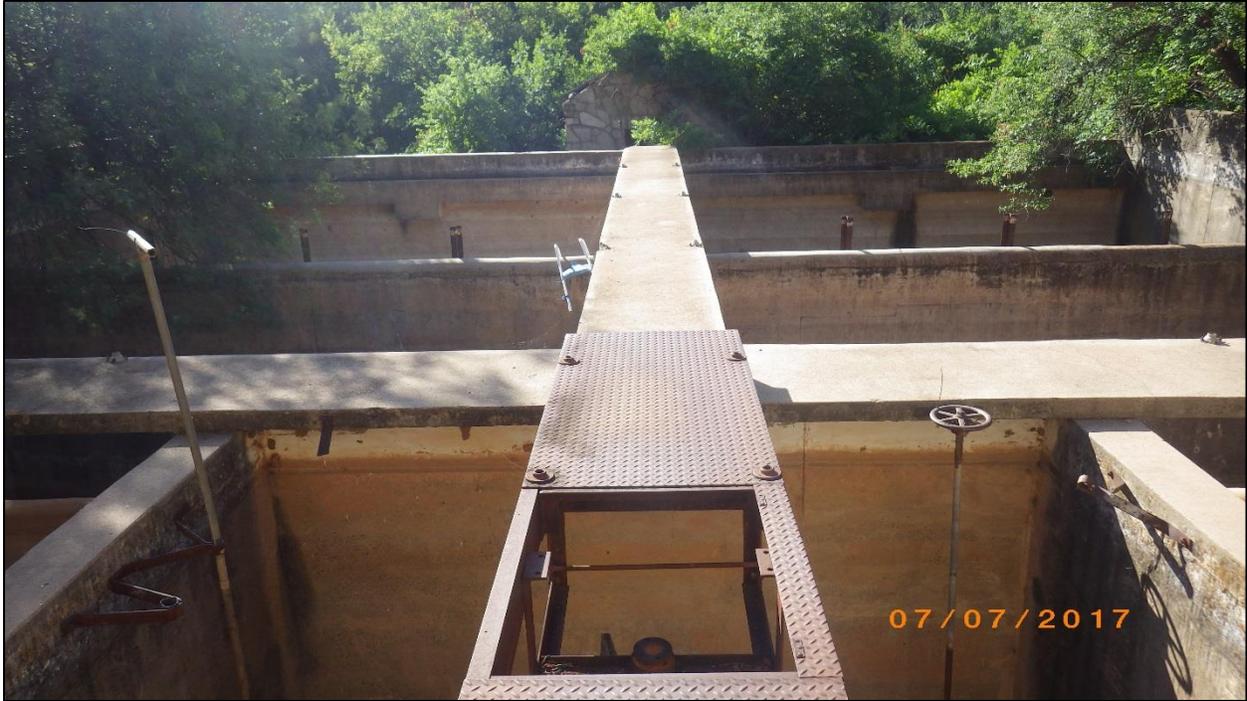
Figure 37. Intake settling basins as part of the intake structure. View is to the southeast.
